DARRYL M. ROBINS CONSULTING INC.
CIVIL & ENVIRONMENTAL ENGINEERING

M09010

**Re: 2014 Annual Report for Lakewood Subdivision Sewage System
Municipality of Northern Bruce Peninsula**

Lakewood Subdivision – Sewage System

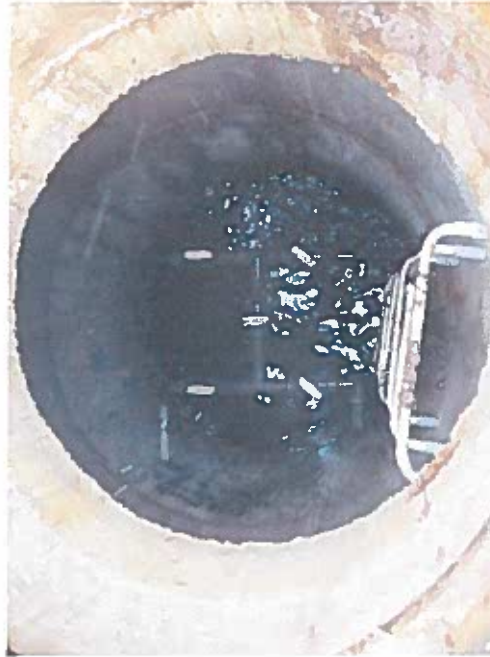
Photo ID: DSCF1944: Splitter Valve Chamber

The splitter valve chamber was inspected and although the chamber did contain some water, there appears to be no need for concern and the valves are above the water level.

- An inspection of the splitter valve chamber to the tile fields was conducted. There were no deficiencies noted. The chamber did contain some water; the valves were above the water level. The water was clear and expected to be from infiltration. The poly-seal (bowl) was full of water and is therefore functioning adequately.

- The discharge control valve stems (dosing chamber) that control discharge to the tile fields are rusty and in poor condition.
- An inspection of the splitter valve chamber to the tile fields was conducted. There were no deficiencies noted. The chamber did contain some water; the valves were above the water level. The water was clear and expected to be from infiltration. The poly-seal (bowl) was full of water and is therefore functioning adequately.

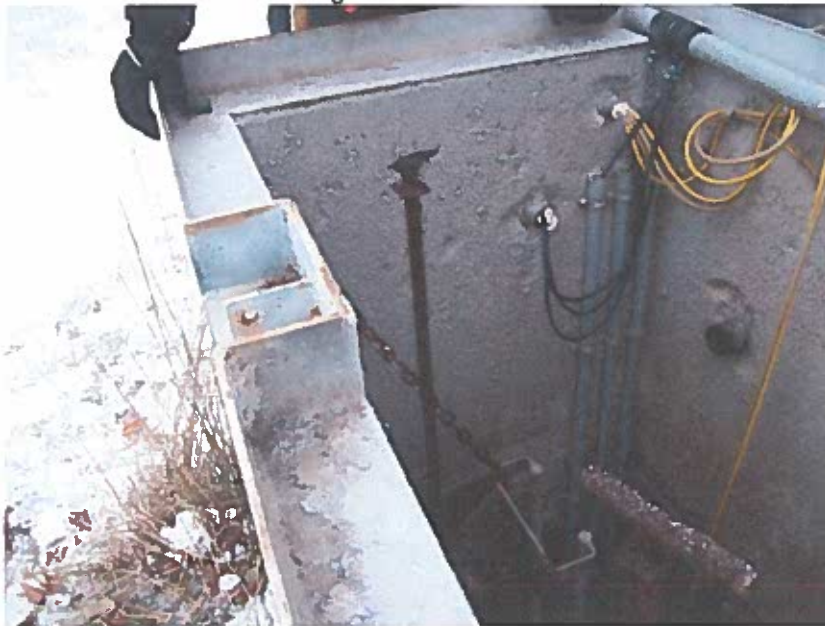
Photo ID: DSCF1946: Dosing Chamber Valves

There was no detectable septic odour encountered except within the vicinity of the access opening of the dosing chamber. One of the two valve stem handles has disintegrated due to the rust. Please see the attached photo. It is recommended that the valve stems be replaced.

- The discharge control valve stems (dosing chamber) that control discharge to the tile fields were operable, however the handles are rusty and in poor condition.

1. OCWA and the Municipality should replace the effluent discharge control valve stems.
2. The "Dosing Pump Elapsed Time Weekly Record Sheets" provided in the Operations and Maintenance Manual originally provided by Henderson Paddon & Associates for recording and collecting data on dosing pump operation should continue to be used by operations staff. Operators should continue to keep a project-specific journal of their site visits, alarm conditions, maintenance, repairs and observations.
3. Operations staff should continue to monitor the air relief valve at SANMH2. There had been maintenance issues with the air relief valve in the past.
4. The Municipality should update the existing Operations and Maintenance Manual to accurately incorporate the upgraded dosing pump components.
