**Re: 2016 Annual Report for Lakewood Subdivision Sewage System
Municipality of Northern Bruce Peninsula**

November 14, 2016

Lakewood Subdivision – Sewage System – Annual Inspection

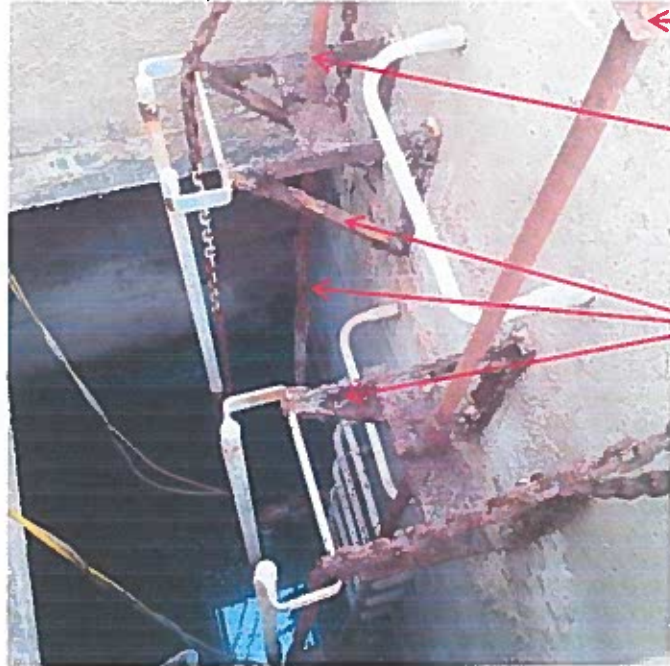
There was no detectable septic odour encountered except within the vicinity of the access opening of the dosing chamber. Both of the two (2) valve stem handles and brackets have disintegrated due to corrosion. Please see the attached photo. It is recommended that the valve stems and brackets be replaced as soon as possible.

- The discharge control valve stems (dosing chamber) that control discharge to the tile fields were not operable, the handles and support brackets are severely rusted and in poor condition.

Photo ID: IMG_2016114 - 131559: Dosing Chamber – Effluent pump bracket and operator valve stem corrosion.

Handle Operator Missing (Typ.)

Operator Shaft Corroded Into Bracket (Typ.)

Severely Corroded Brackets and Valve Operator Shaft

1. OCWA and the Municipality should replace the effluent discharge control valve stems and brackets as soon as possible.
2. The "Dosing Pump Elapsed Time Weekly Record Sheets" provided in the Updated Operations and Maintenance Manual should continue to be used by operations staff. Operators should continue to keep a project-specific journal of their site visits, alarm conditions, maintenance, repairs and observations.
3. Operations staff should continue to monitor the air relief valve at SANMH2. There have been maintenance issues with the air relief valve in the past and the liquid contents of the chamber appear to be of a septic nature.
4. The hole in the dosing chamber lid for the safety chain attachment is corroded and the hole should be relocated and redrilled to ensure that there is adequate strength to support the weight of the lid structure.

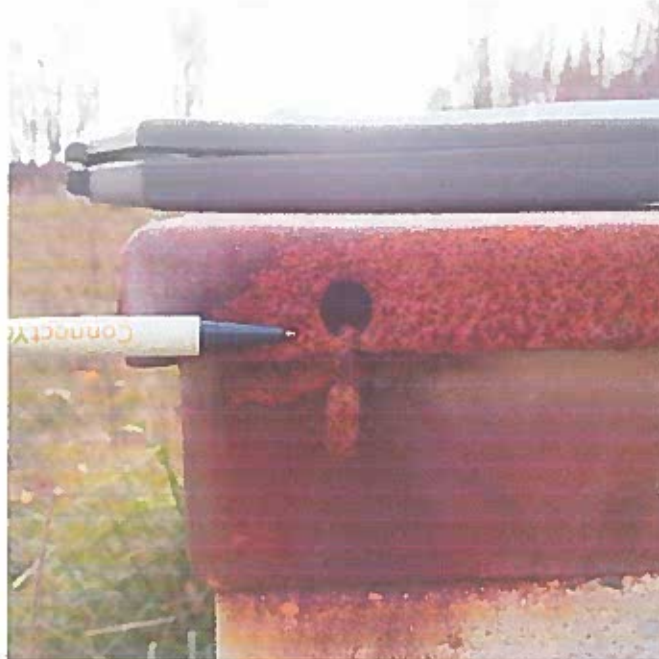
Photo ID IMG_20161114 - 132202: Corrosion of safety chain attachment point on the dosing lid.

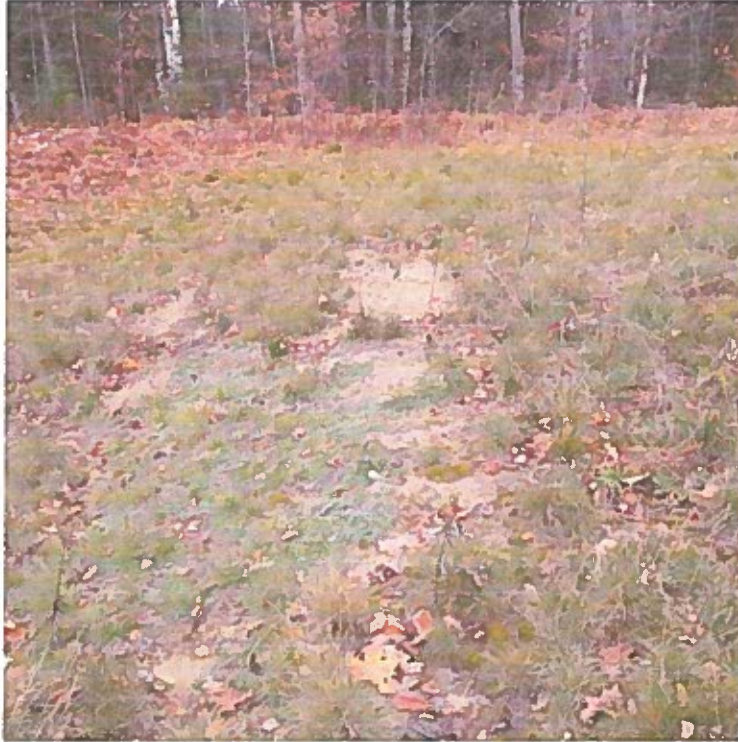
DMRC's inspector walked around the tile field and septic tank area during the inspection. Some minor bare spots were observed on the slopes of the tile bed. There were also signs of erosion on the top of slope at the southeastern and southwestern corners of the tile bed. It is suggested that these areas be topsoiled and seeded in the spring. Please refer to the attached photos.

Photo ID IMG_20161114 - 125659: Topsoiling required on south slope of tile field.
Southwestern corner of tile field shown in photo.

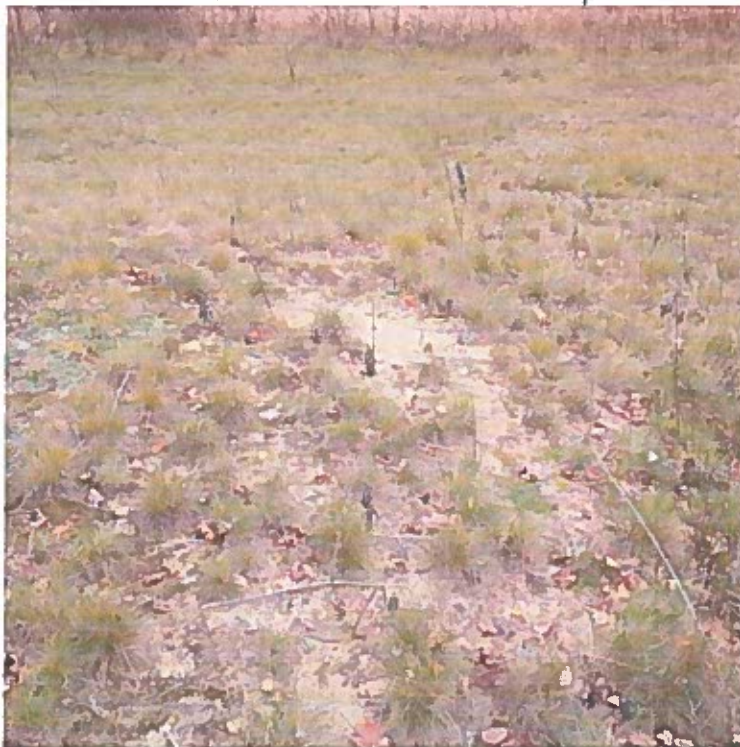
Photo ID IMG_20161114 – 125617: Topsoiling required on south slope of tile field.
Southeastern corner of tile field shown in photo.
